Inspection Report

123 Any Street
My Town, AR

Prepared by:
ProTeam Inspectors

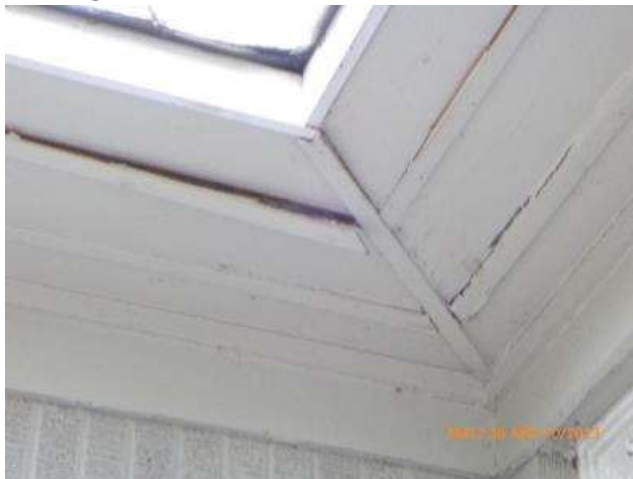
2.3 Damage:

Loose materials were observed. Damage areas were observed. Loose materials are subject to wind damage.

Action: Repairs Recommended.

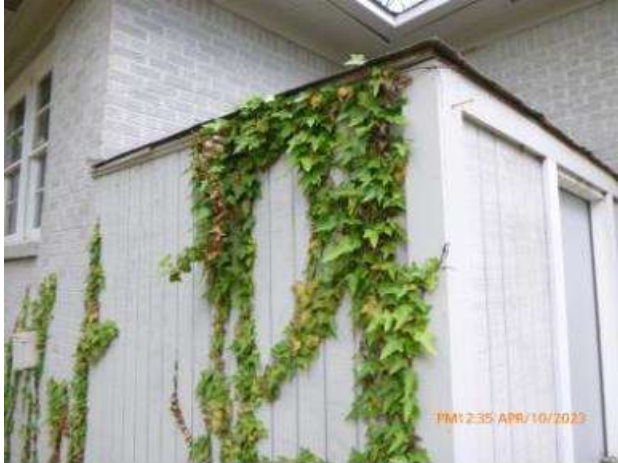
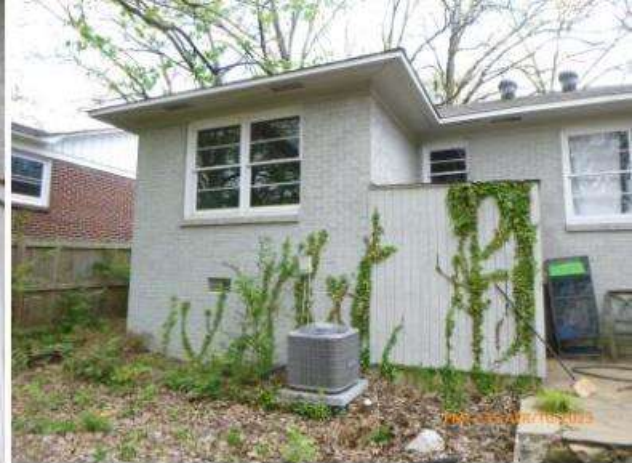
2.5 Observations

Keep plants 12 inches away from the structure and AC units to prevent damage and deterioration.

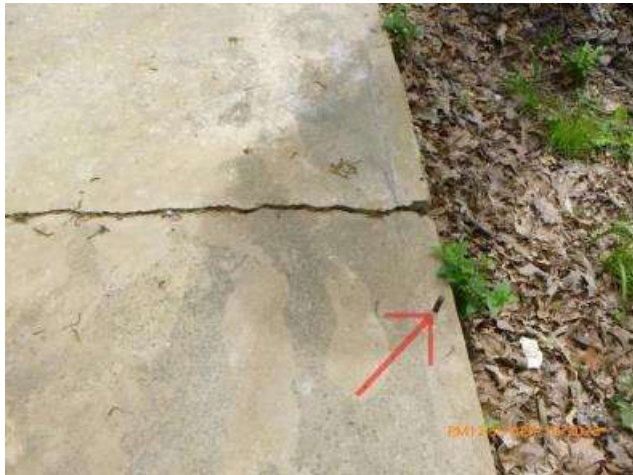
2.7 Observations

The concrete slab behind the house has anchor bolts sticking up out of the slab. This could possibly indicate that there was some structure on this slab at one point in time. The anchor bolts that are sticking up are a trip hazard. We recommend their removal. Additionally, the slab has a fairly significant crack. Portions of the crack are raised and present a trip hazard. Repairs recommended.

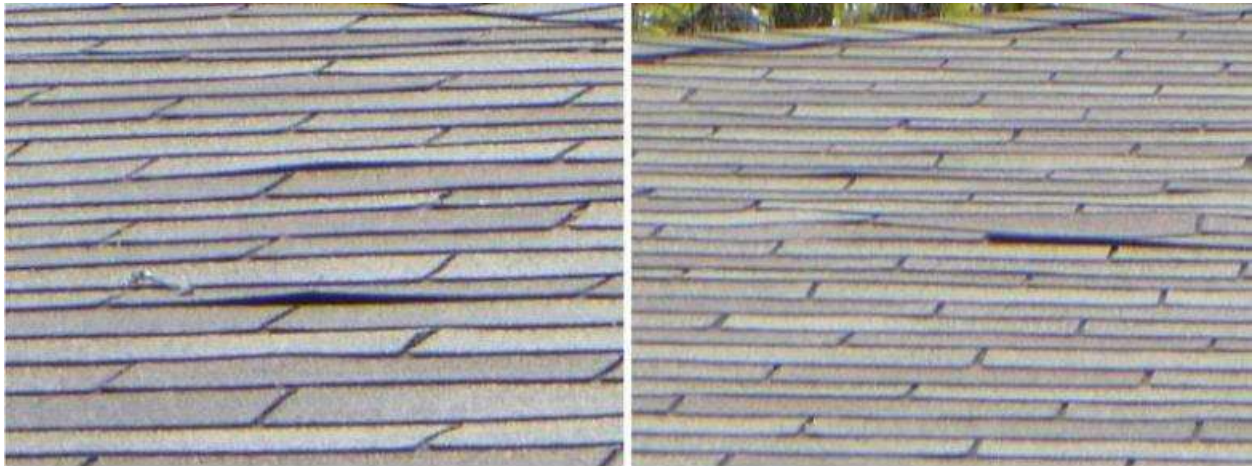
3.4 Observations

Something is keeping the shingles from laying flat and properly sealing themselves together. High winds could damage them and/or cause leakage. Dips or sagging was observed in the roof structure. This may allow damaging moisture to infiltrate the structure.

Based on the condition of the roof, normal roof maintenance is recommended. This consists of evaluating, repairing or replacing individual components. This helps prevent leaks and should be performed on a regular basis about every 3 to 5 years.

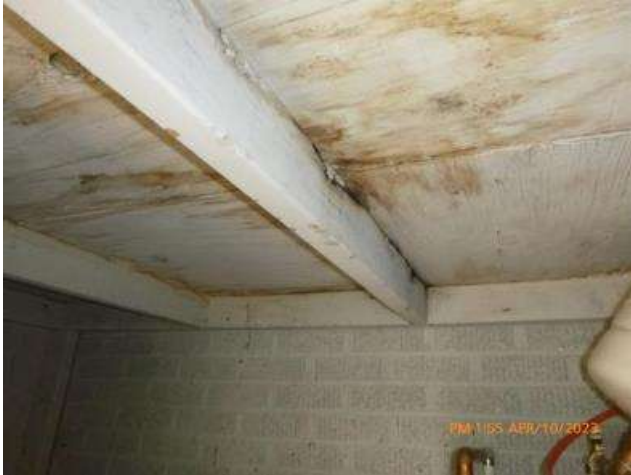
There were signs or indications of past water leakage or infiltration. We were not able to determine if the leakage is current or not. Shed roof.

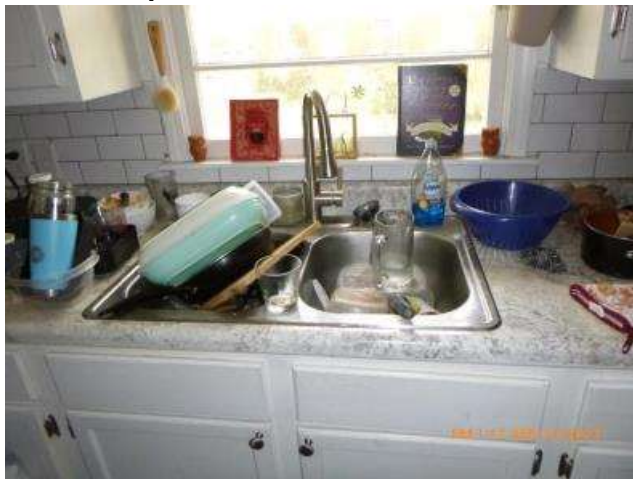
5.3 Countertops & Cabinets

Counter: Access restricted.

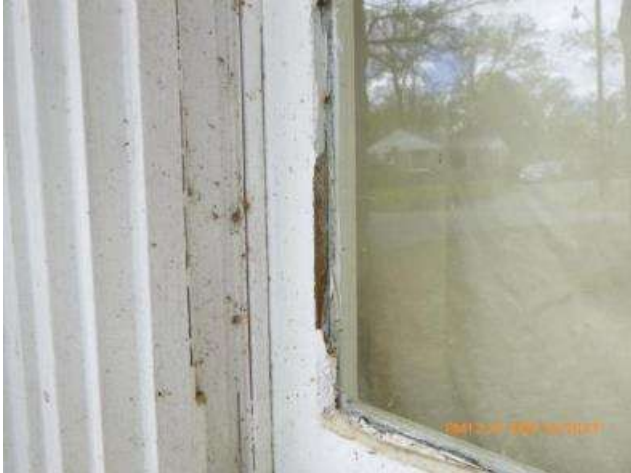
5.5 Windows

A portion of the glazing or the retaining strips, holding the windowpane in its frame, needs repair or replacement.

Inefficient old single pane windows observed. Repairs and upgrades are recommended in order to help with the energy efficiency of this home.

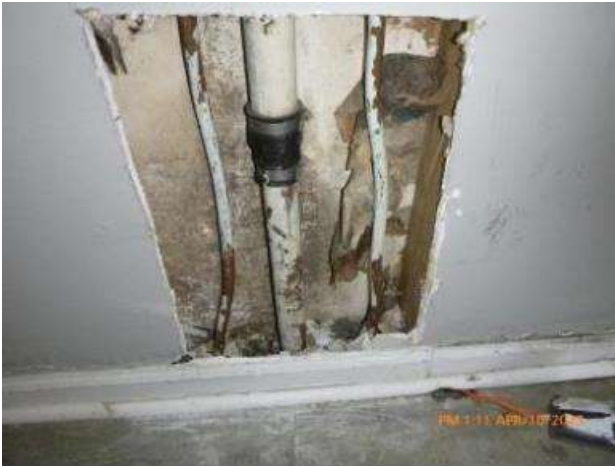
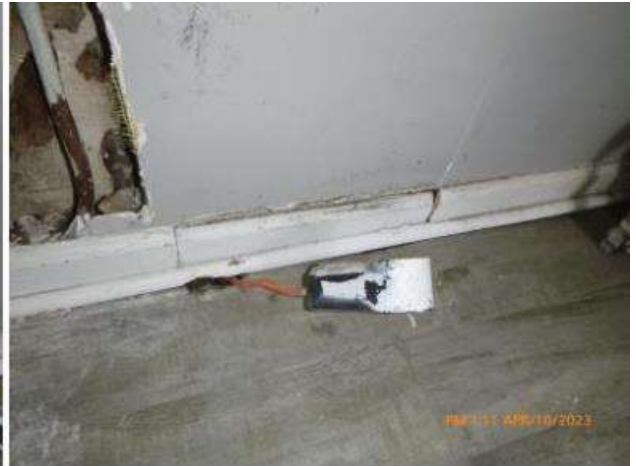
5.7 Walls

Damage observed. Significant damage or holes were observed. An area of the wall was opened up to expose the plumbing components.

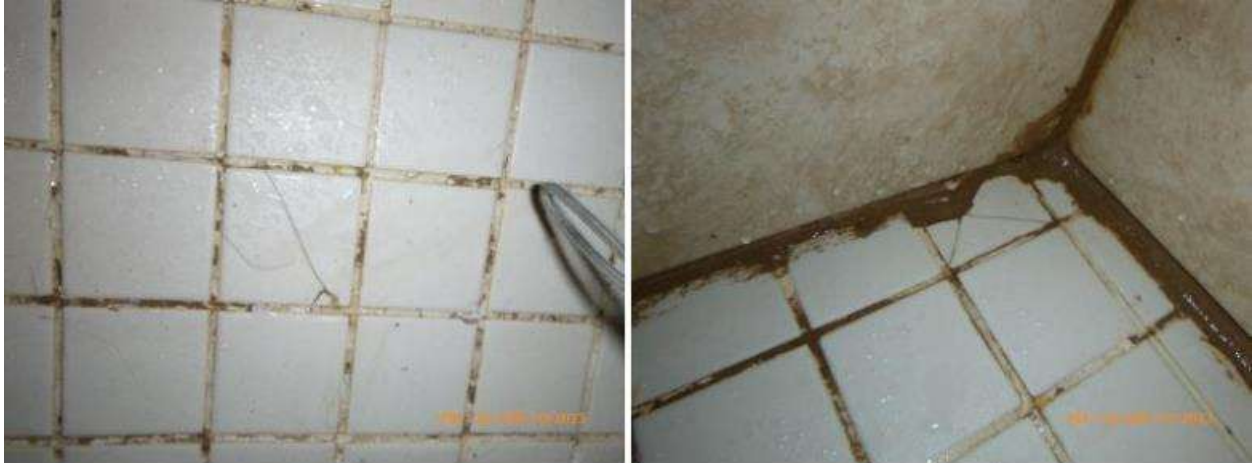
5.9 Observations

Cracks, damage and/or deterioration was noted within the tub/shower. Damaged, cracked and/or deteriorated tiles were noted. This may allow damaging moisture to penetrate the underlying materials.

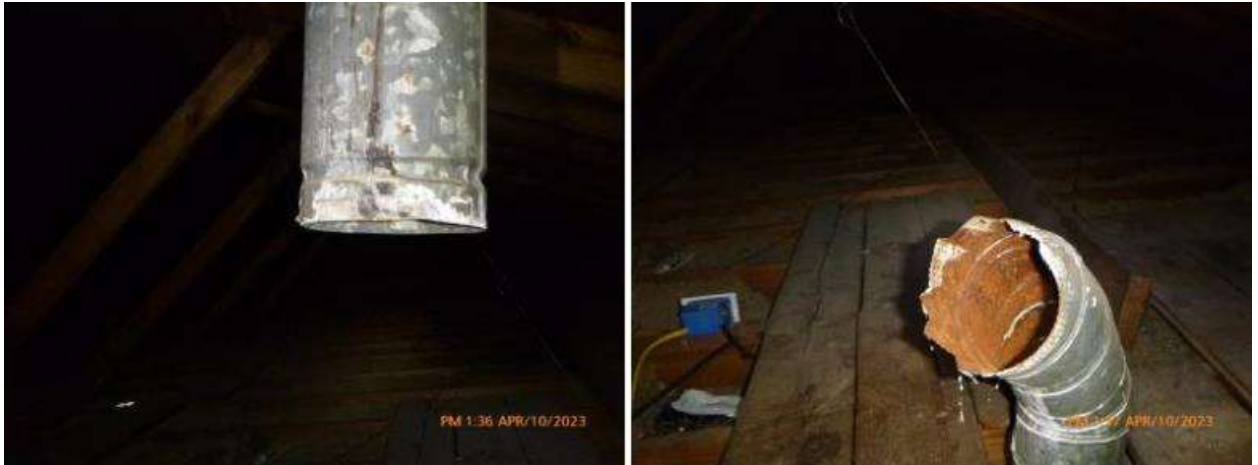
7.5 Observations

Danger! One or more of the pipe joints or the pipe itself needs to be repaired or replaced. Damaged, disconnected joints or open seams were observed. This condition allows harmful combustion gases to escape.

Action: Repairs Recommended.
Safety Risk: **Do Not Use** or operate until repairs or evaluation have been completed.

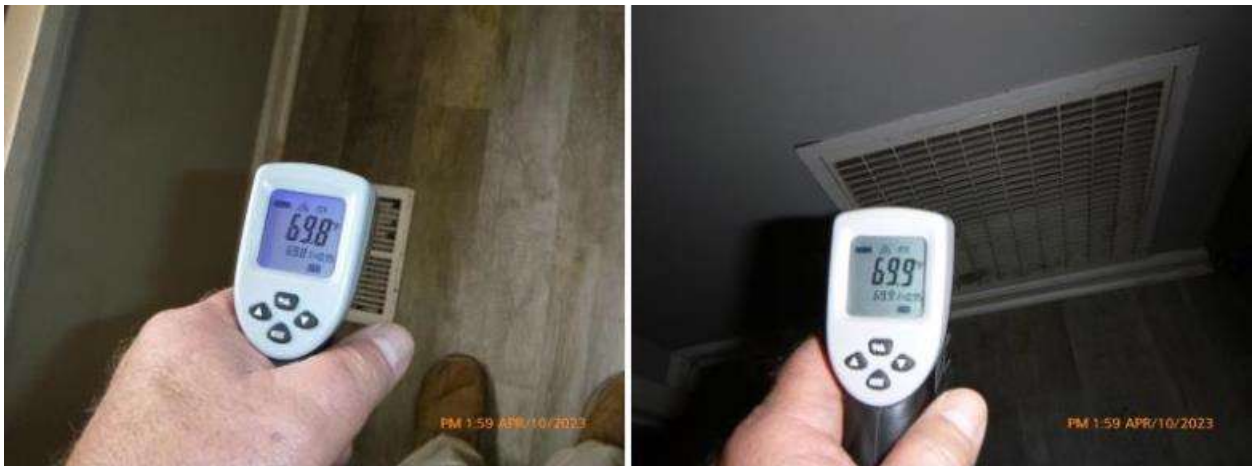
7.7 Air Temp Drop:

The AC was malfunctioning. It was not producing the expected cooling normally observed in other system. Further investigation and servicing by a HVAC technician is recommended.

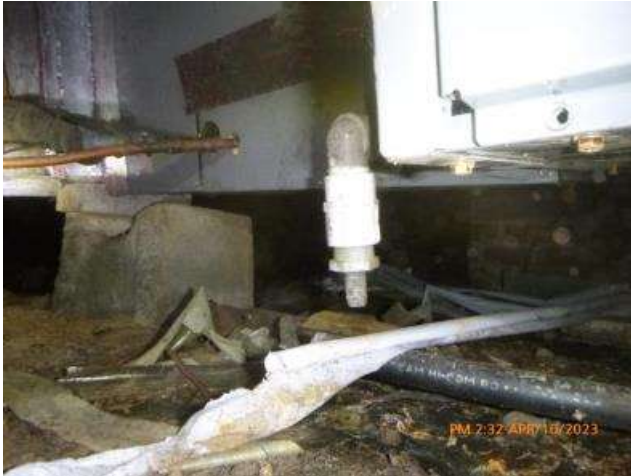
7.10 Condensate Line:

The condensate drain line was damaged, broken or disconnected.

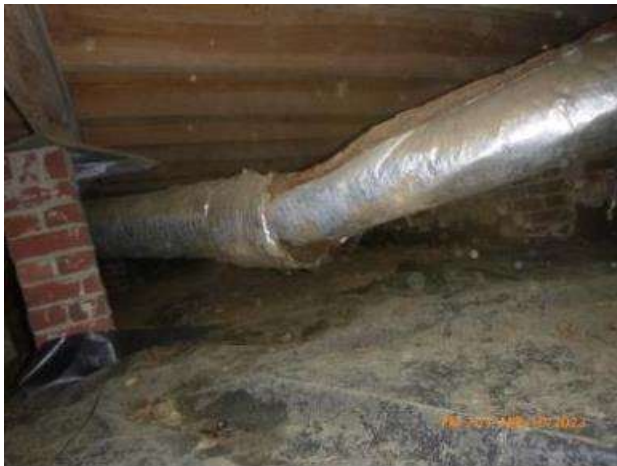
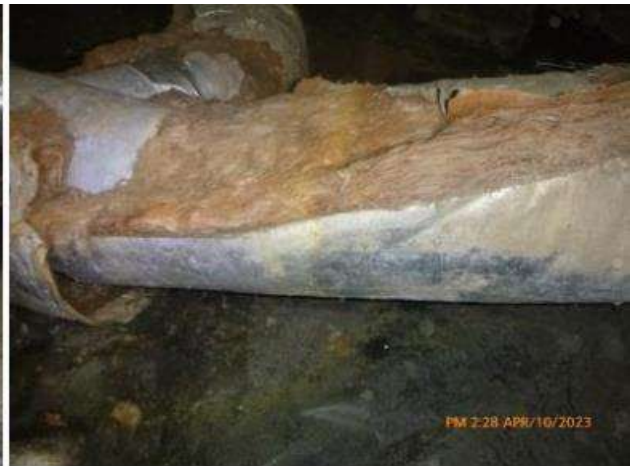
7.12 Ductwork Condition:

Joints in the ductwork have been dislocated and are leaking. Portions of the ductwork have sagged. Damaged, improper or inadequate supports were observed. Dislocated and leaking ductwork is suspected. Air leakage suspected. Missing or damaged insulation was observed.

Further evaluation by a HVAC technician is recommended. Only licensed and trained HVAC technician is allowed to fully evaluate the system.

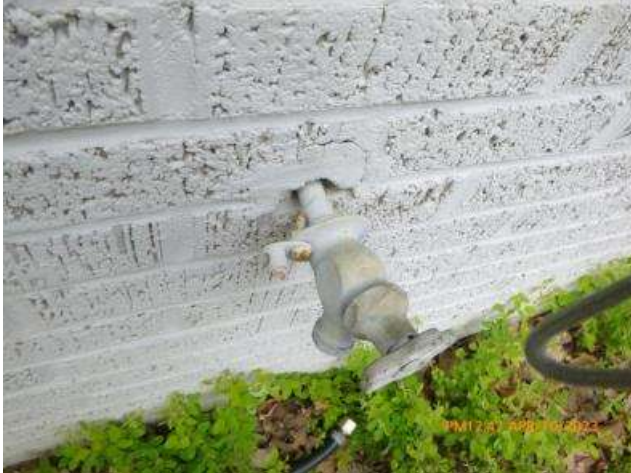
8.7 Observations

Loose components were observed. Damage or leaks are possible. It is not properly supported or secured to the building. The plumbing pipe is the only support for the hose bib.

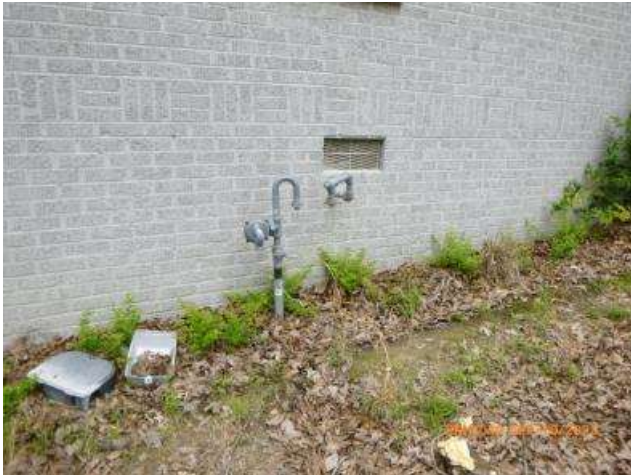
8.9 Observations

The site for the gas meter was located. The meter has been removed. The gas was off. The gas system and the gas appliances were not able to be tested. Only visually observable defects are reported. The meter has been removed.

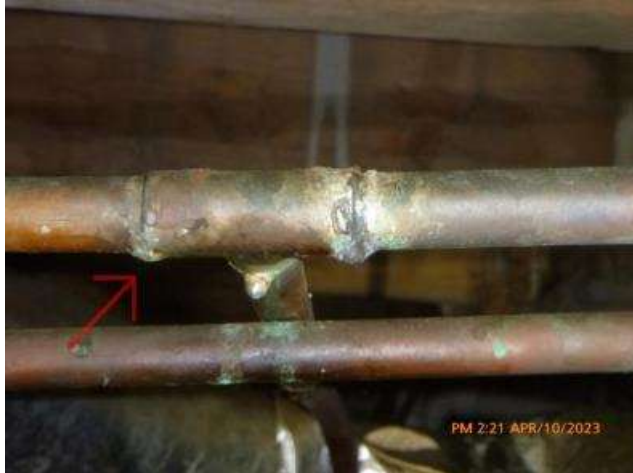
8.11 Observations:

Leakage was observed in the plumbing system. Water damage is possible.

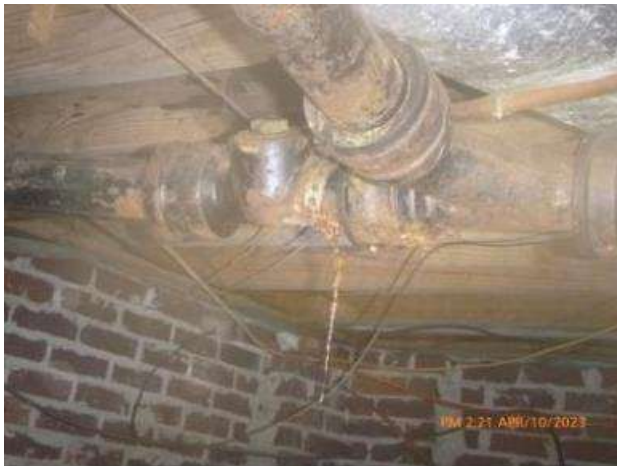
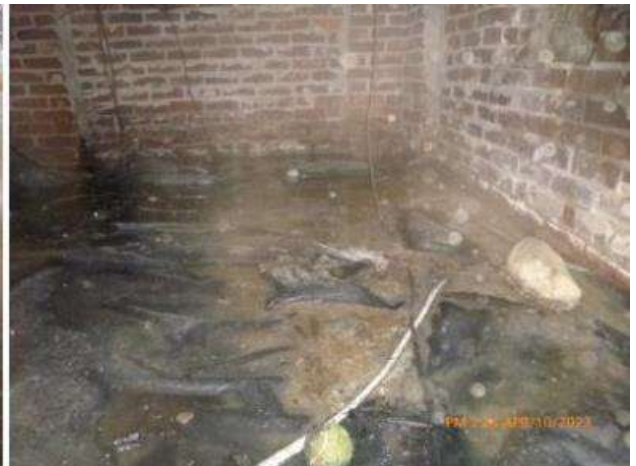
Active leakage was observed. Damaging rust or corrosion observed. A significant amount of water was observed standing in the crawl space.

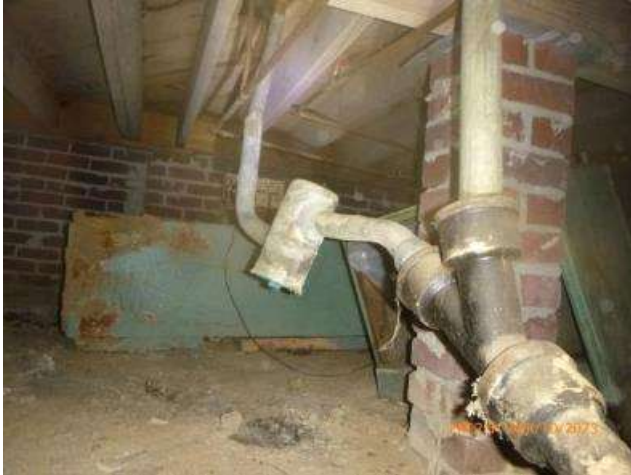
An obsolete drum trap was observed. This device has a history of failing to perform properly.

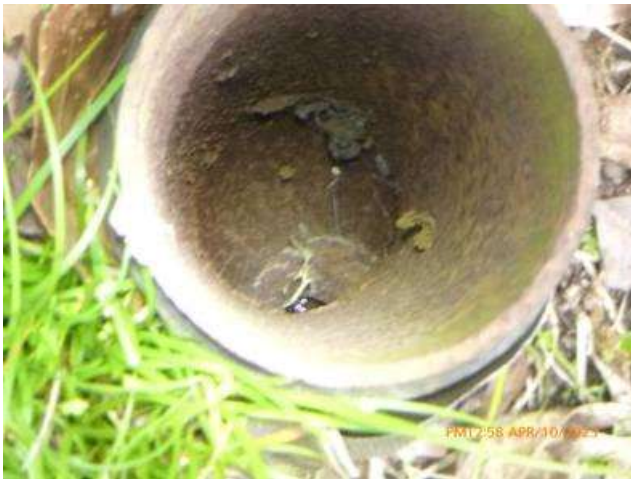
An open sewer pipe was observed in the backyard. These sewer access cleanouts are normally capped.

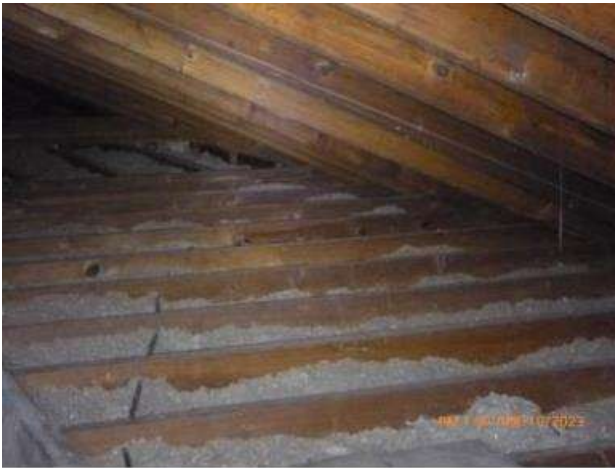
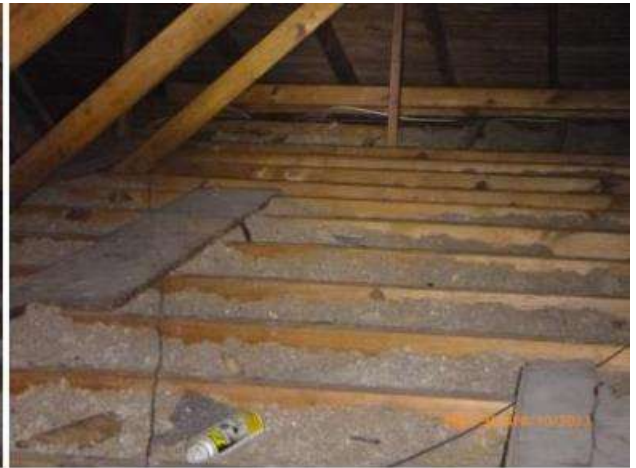
9.2 Attic Observations

The insulation has been disturbed or compacted. The insulation in some areas was less than the minimum recommended amount of R-38. We recommend adding additional insulation. Cellulose type of insulation is preferred.

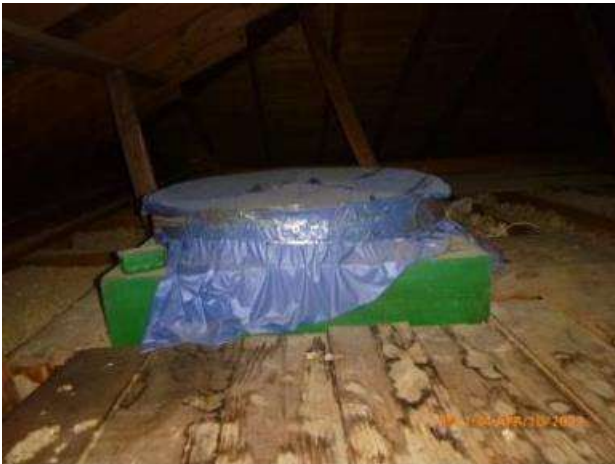
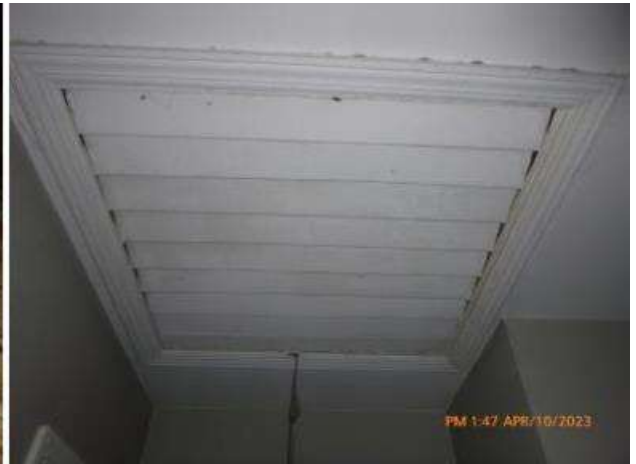
A whole house fan was observed. Leaking large amounts of the interior air into the attic and increasing heating and cooling cost is expected. Removing the fan will increase your homes energy efficient.

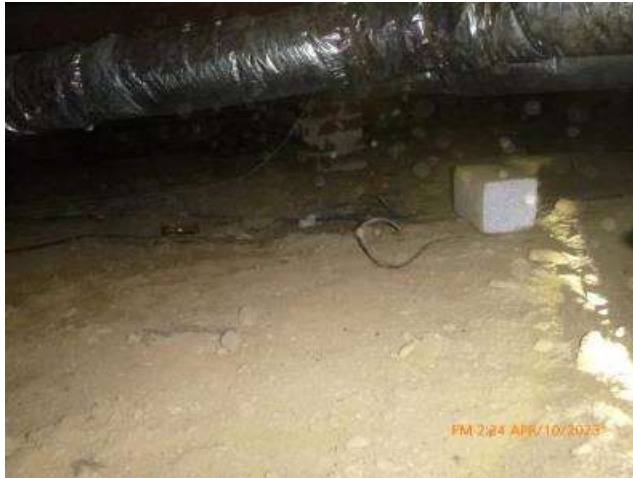
9.5 Crawlspace – Basement Ground & Soil Observations

Crawlspace - Ground: Partial vapor barrier installed. Recommend additional vapor barrier be installed to completely cover the ground.

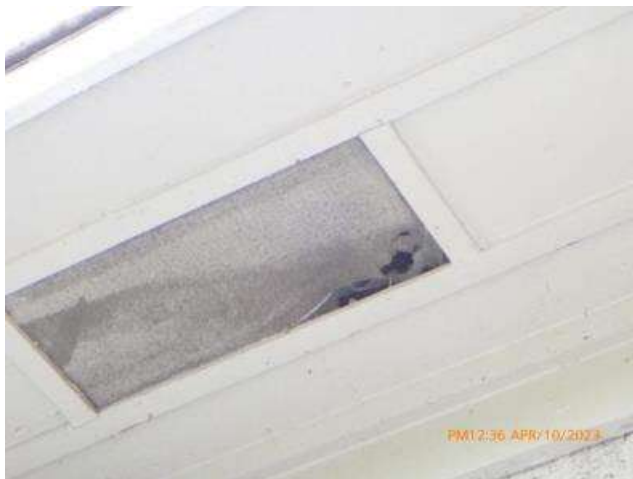
9.7 Attic Observations

The screen over the vent was missing or damaged. Repair or replacement may help stop insects or animals from entering the attic space.

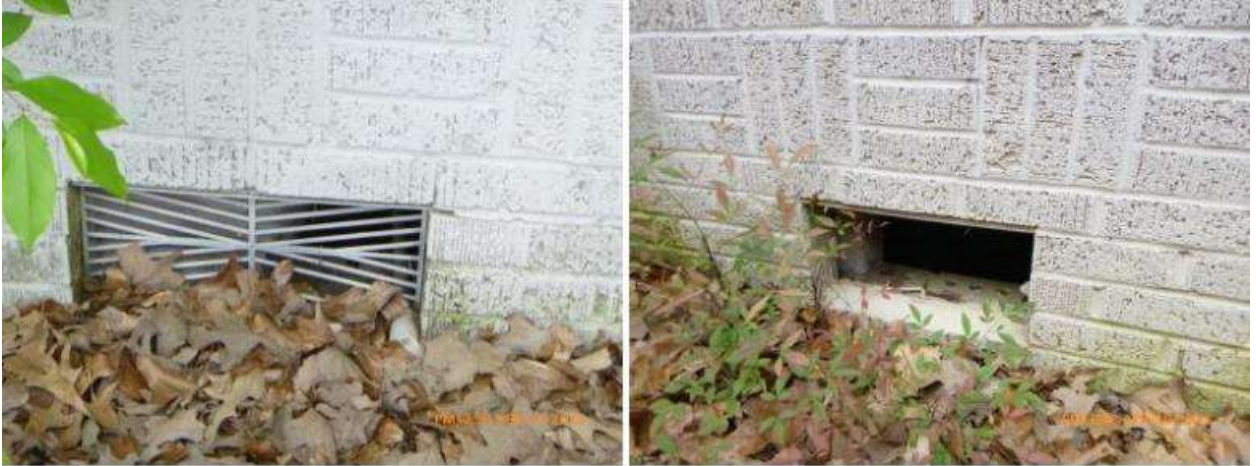
9.8 Crawlspace – Basement Observations

Crawlspace vents and/or their screening were damaged or missing. Repairs recommended to help prevent animal and insect entry.

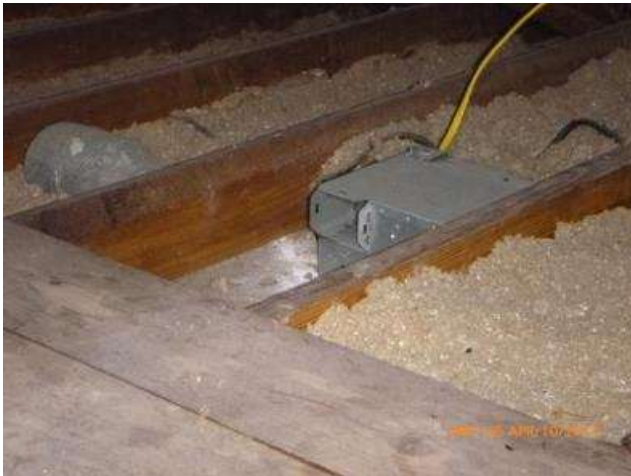
9.9 Bathroom Observations

Bathroom Ventilation: The extension for the discharge of the bath vent is missing, damaged or too short. Additional insulation or other materials will cover the discharge making it ineffective.

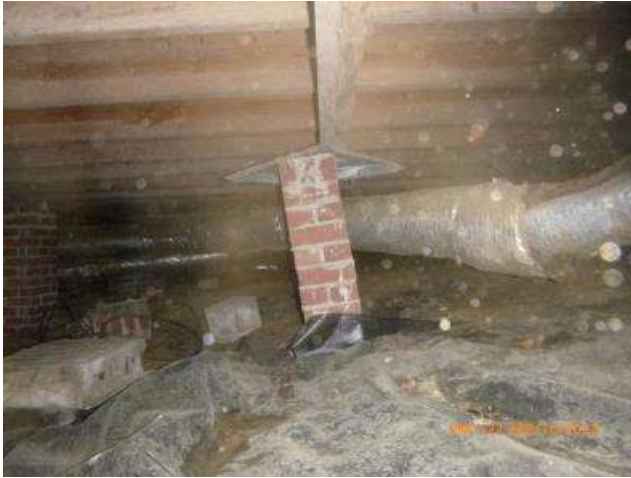
10.4 Post & Piers

Damaged or cracked piers were observed. Leaning, damaged, shifted or out of plumb components were observed. Continued deterioration and/or movement may result in damage or failure of this structure. Further evaluation by a professional specializing in this area is recommended. Multiple piers. One pier has already fallen down.

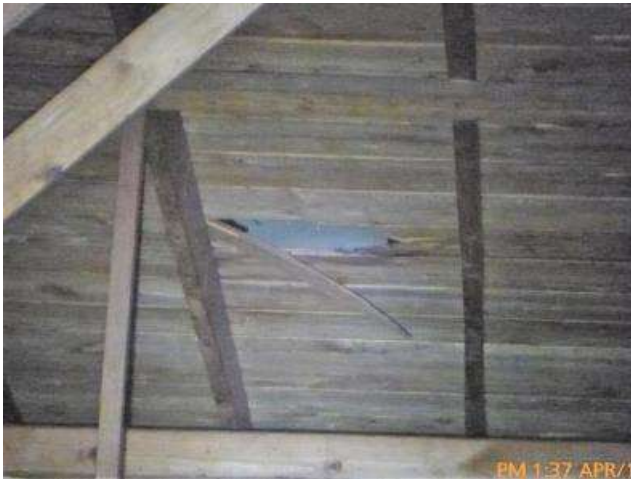
10.6 Damage:

Damaged roof decking was observed that was not replaced. This makes the roof potentially dangerous to walk on.

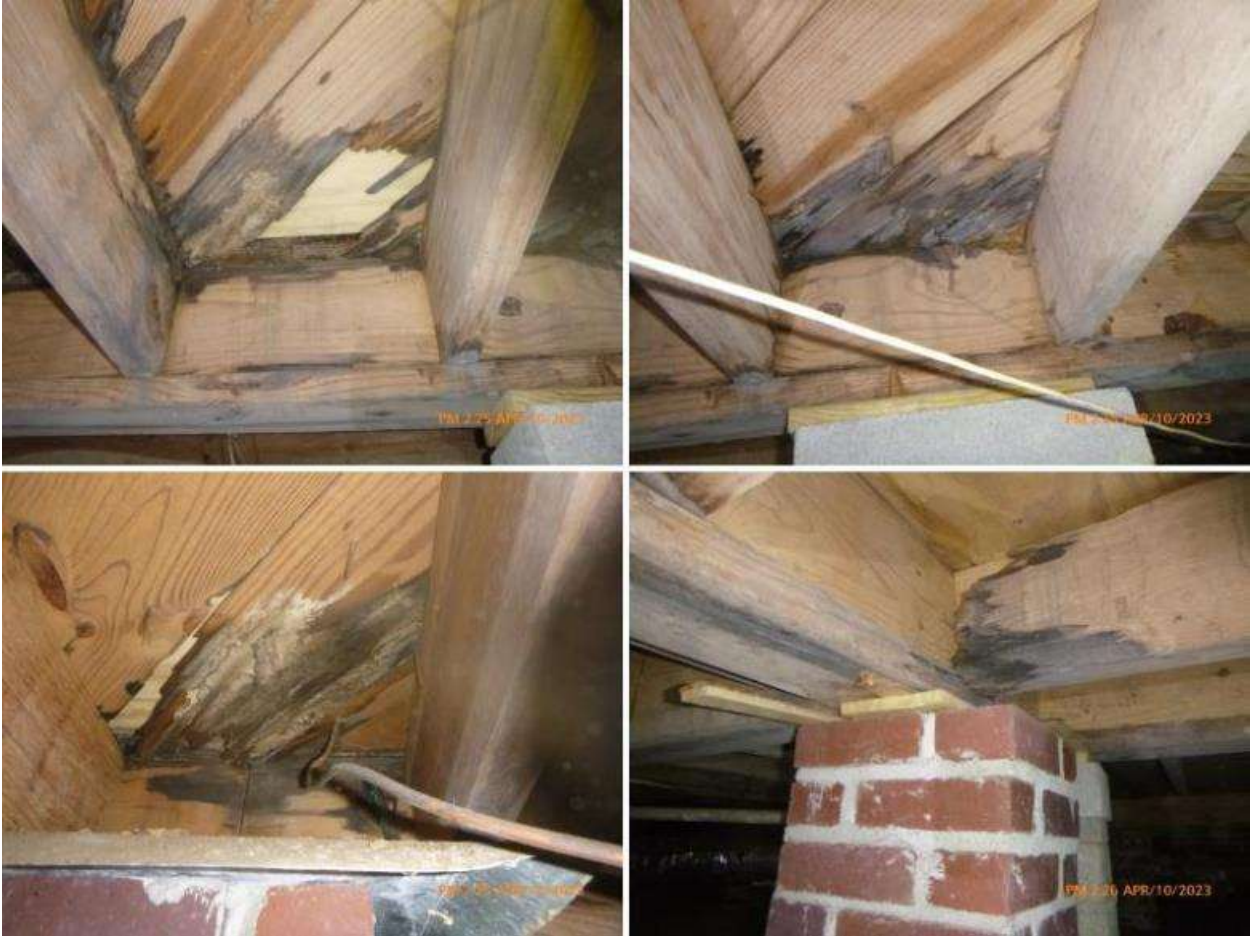
10.8 Damage:

This structure has multiple deficiencies, too many to enumerate in this inspection. Due to its poor condition and apparent advanced age we believe extensive repairs will be required.

Rotting or decaying wood was observed. Moisture damage was observed. Water has penetrate the structure. Makeshift, inexpensive or band-aid type repairs were observed. Instead of replacing the damaged components, patches, filler materials or other temporary and ineffective repairs were made. These types of repairs have a history of failing and allowing further damage to occur.

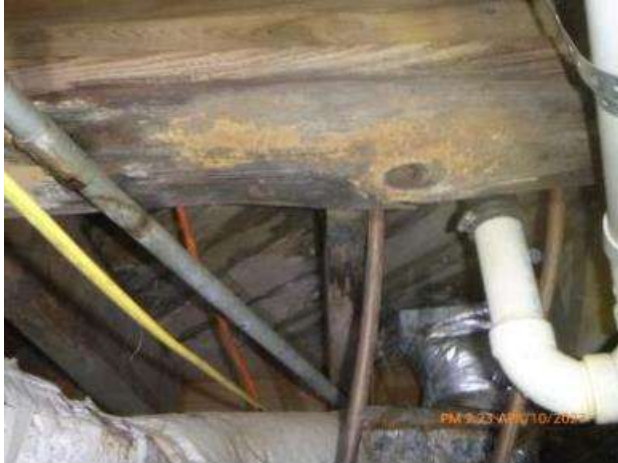
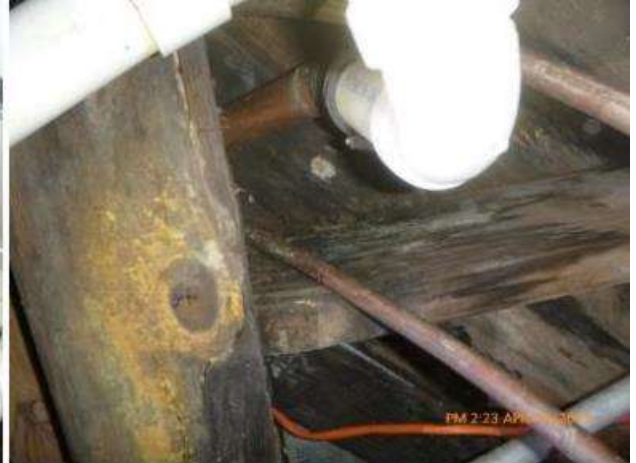
10.9 Structural:

Sagging or dipping was observed. Unlevel flooring observed. Multiple Locations. Broken Structural members observed. Example kitchen floor.

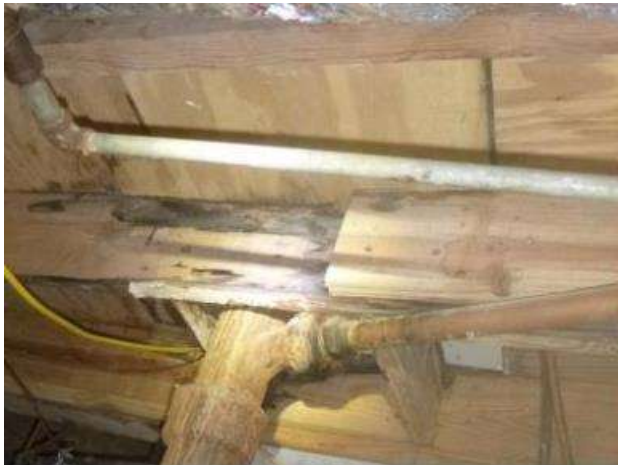
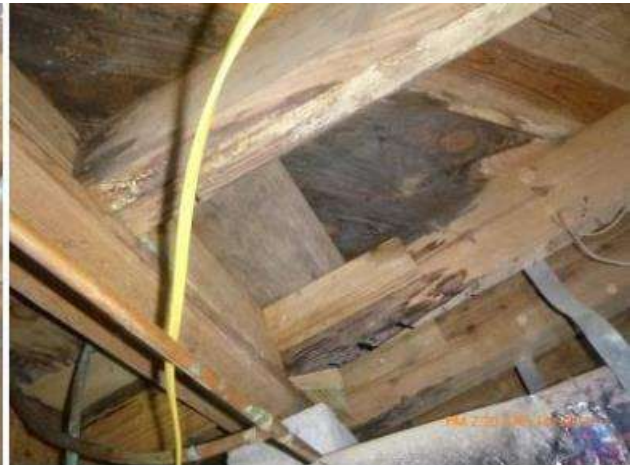
Makeshift, inexpensive or band-aid type repairs were observed. Multiple Locations.
